SECOND URBAN ENVIRONMENTAL SANITATION PROJECT

REHABILITATION, CLOSURE, BID EVALUATION, CONSTRUCTION SUPERVISION AND
CONTRACT MANAGEMENT OF THE OBLOGO No. 1, MALLAM MAIN (No.1 &2) AND
MALLAM SCC DUMPSITES IN ACCRA

FINAL COMPLETION REPORT FOR WORKS ON DUMPSITES ACCRA

January, 2014

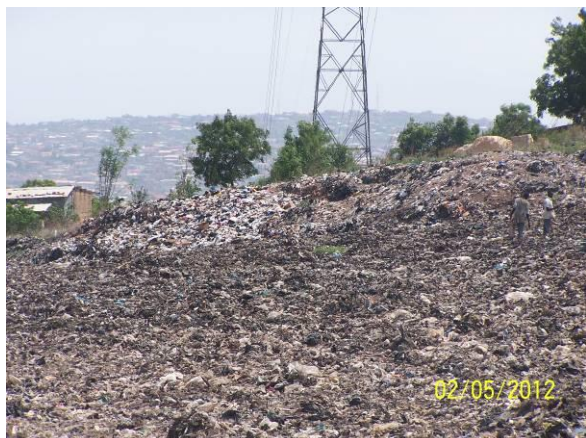
13. Dumping at the site had to be restricted due to the presence of ECG pylons. Leachate from the refuse gradually seeps into an existing reinforced concrete sump built as part of the initial attempt to rehabilitate the site.

Plate 1: Oblogo No.1 refuse dumpsite showing the ECG pylons on the site

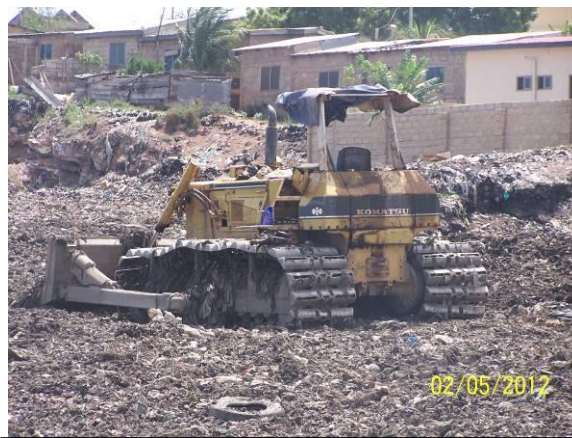
Plate 2: Levelling and compaction of refuse

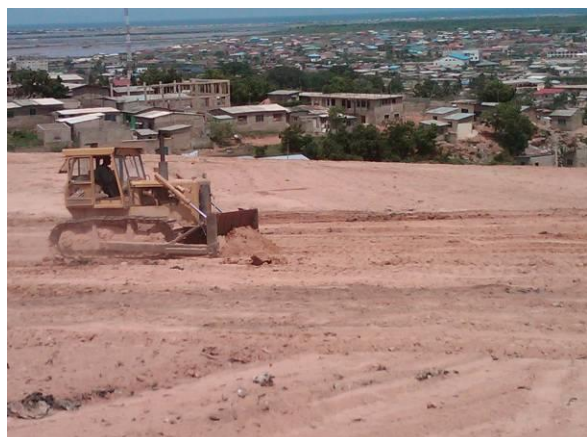
Plate 3: Placement and spreading of Clay – first layer

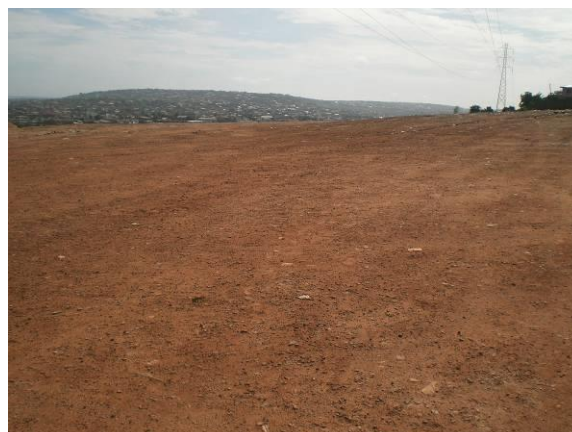
Plate 4: Final compacted surface after capping of the site

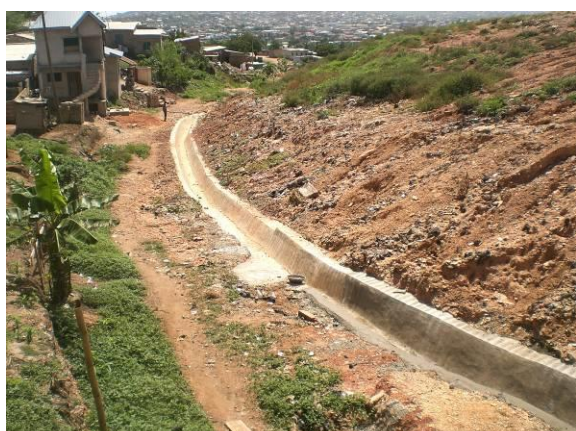
Plate 5: Peripheral drain for conveying surface run-offs from site into existing drainage systems in community

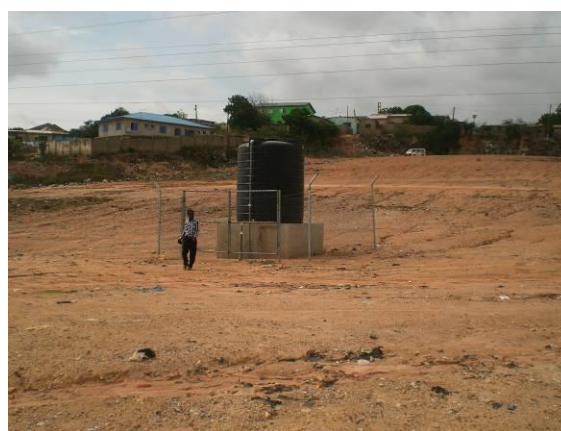
Plate 6: Attenuation tank in a protective fence. WC-SIRL system installed

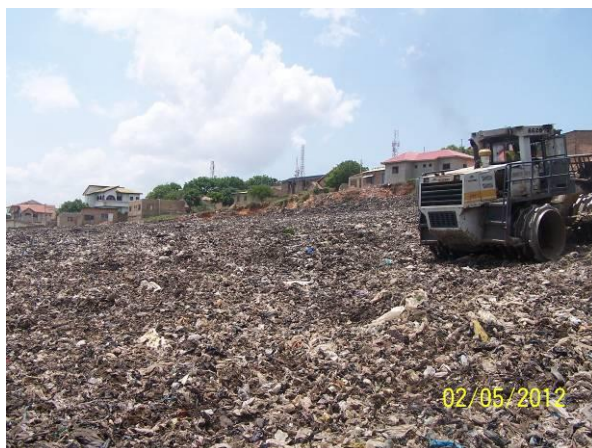
Plate 8: Levelling and compaction of refuse

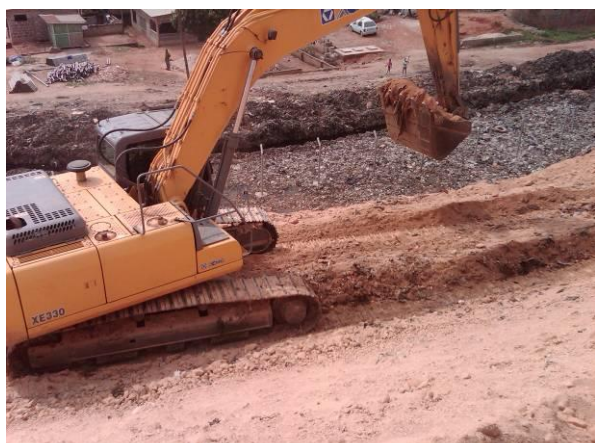
Plate 9: Grading to form slopes and berms

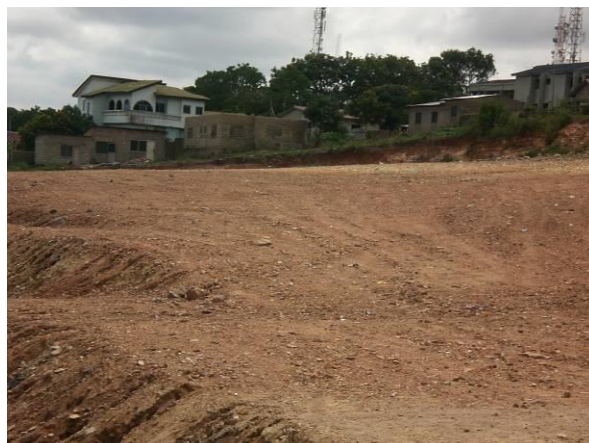
Plate 10: Final compacted surface after capping with laterite

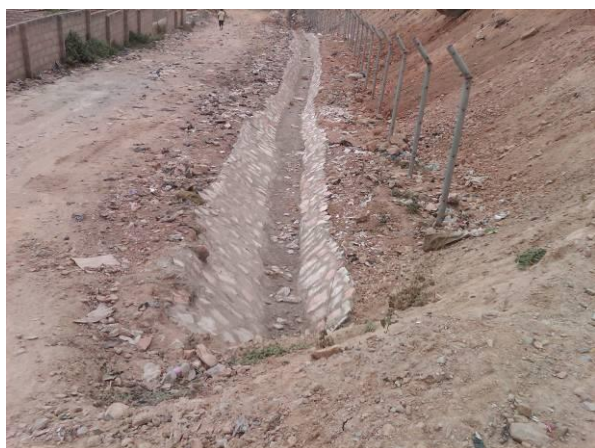
Plate 11: Stone pitched peripheral drain for conveyance of surface run-offs

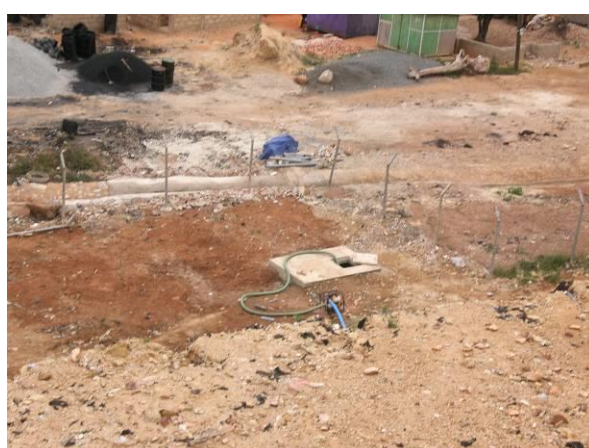
Plate 12: 10m³ Concrete sump for leachate storage WC-SIRL system installed.

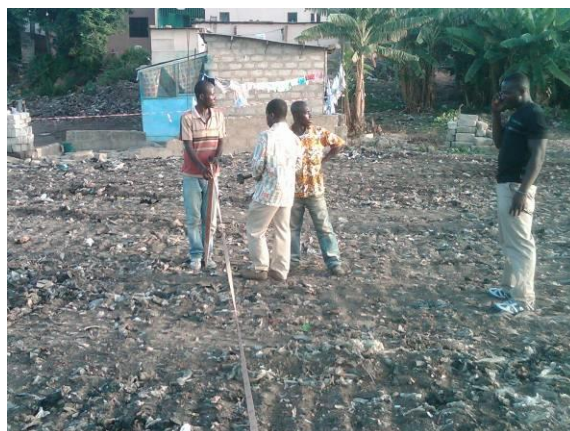
Plate 14: Demarcation of the sub-surface irrigation/recirculation system on site

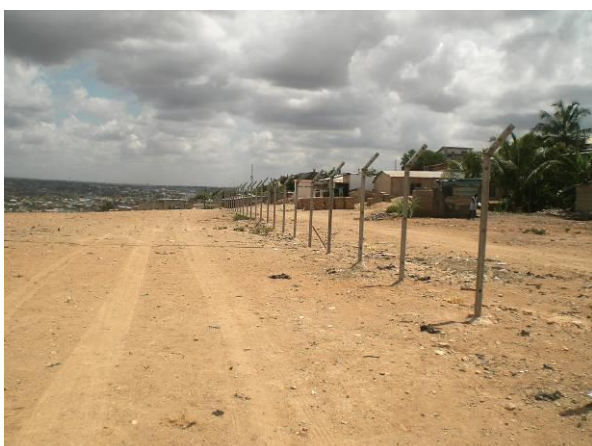
Plate 15: Final compacted surface of Mallam No.1 after placement of laterite layer

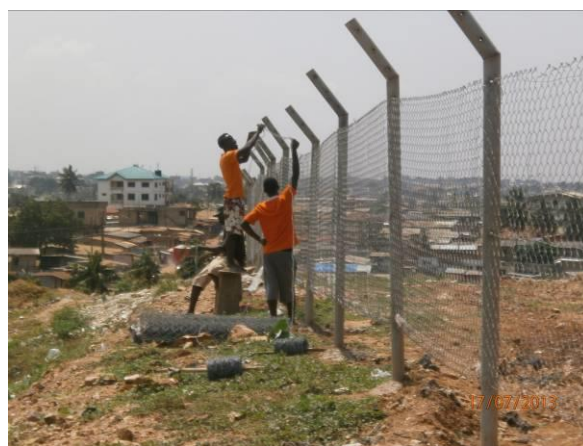
Plate 16: Installation of Mallam No.1 site fencing

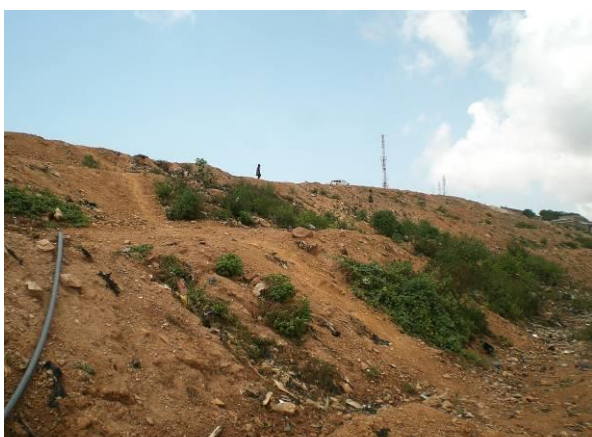
Plate 17: Completed slope surface with planted local shrubs

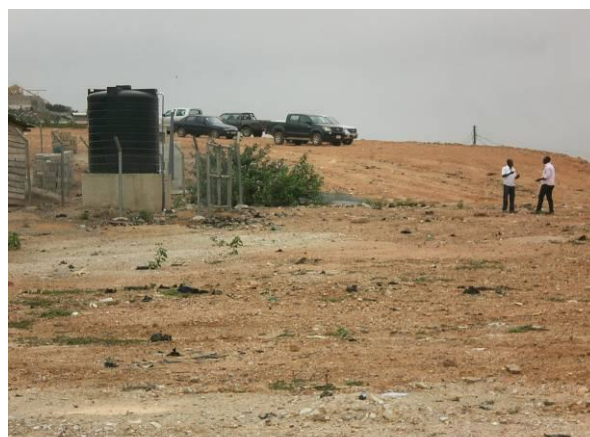
Plate 18: Attenuation tank in a protective fence on the completed capped surface

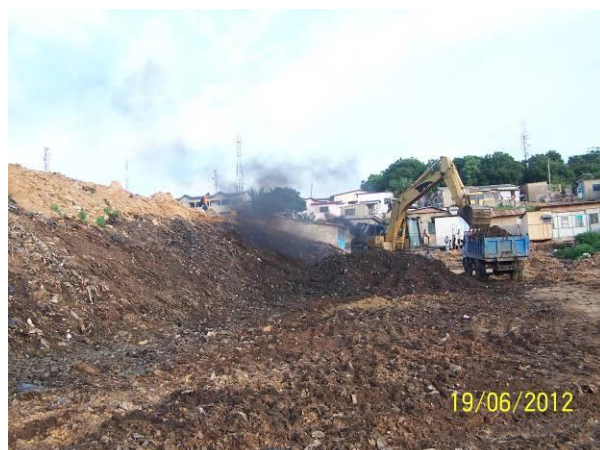
Plate 20: Formation of slopes and berms of Mallam No. 2

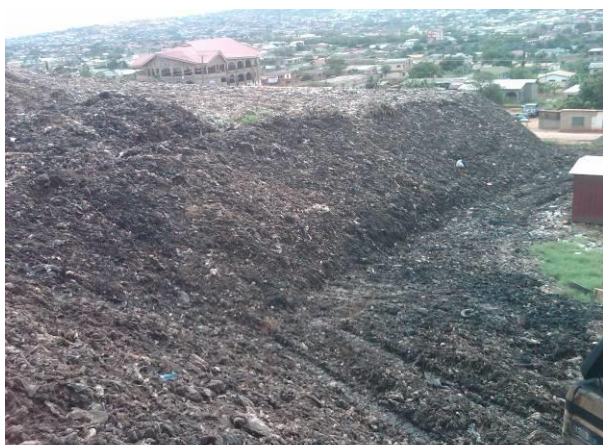
Plate 21: Completed Eastern side slopes of Mallam No.2 dumpsite.

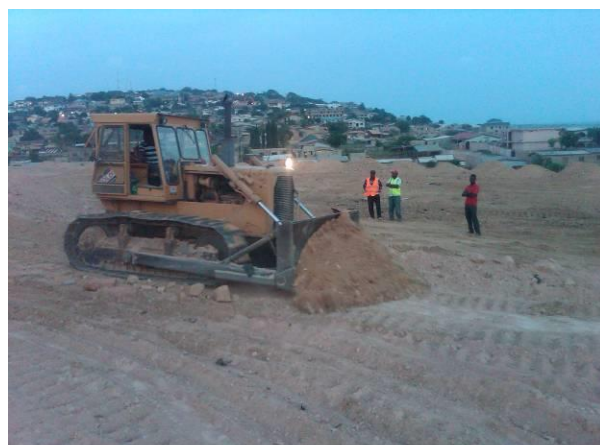
Plate 22: Placement and leveling of clay layer

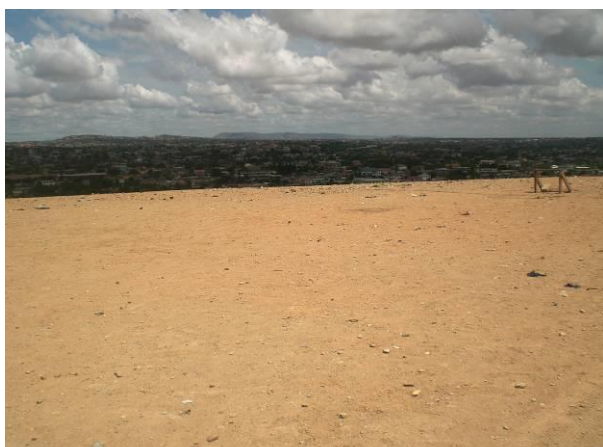
Plate 22: Final compacted surface of after placement of laterite layer

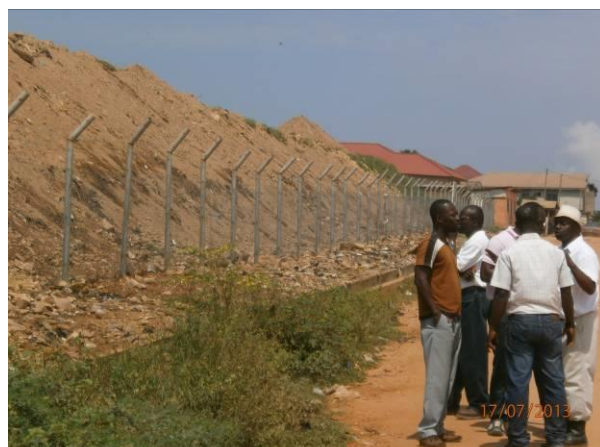
Plate 23: Fenced Mallam No.2 rehabilitated site

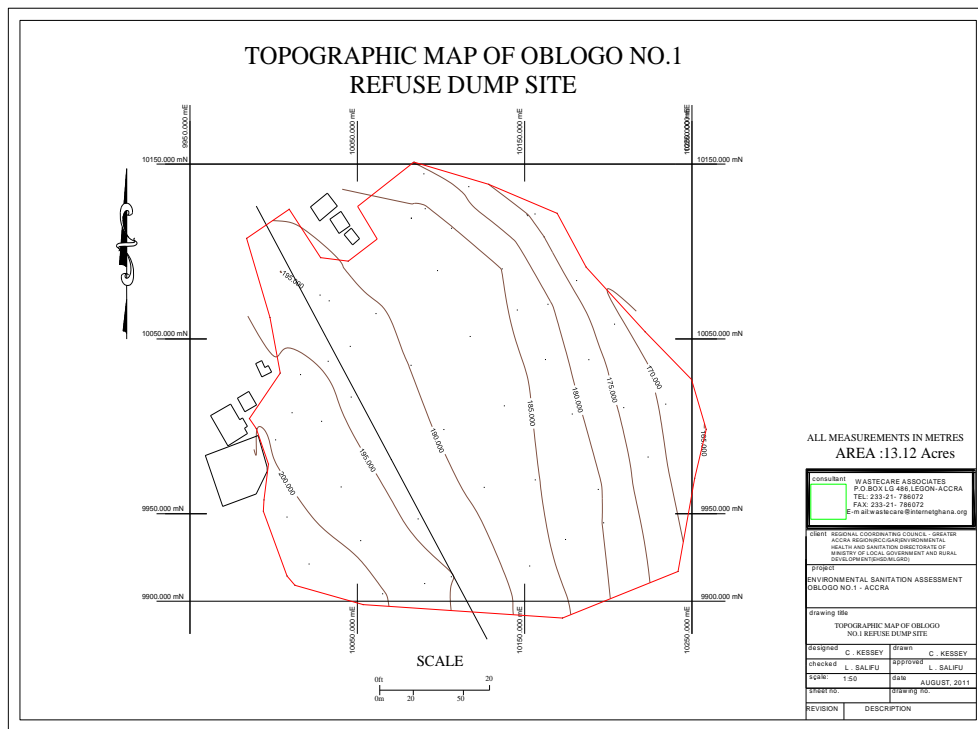
Figure 1: Topographic Map of Oblogo No1 Refuse dumpsite

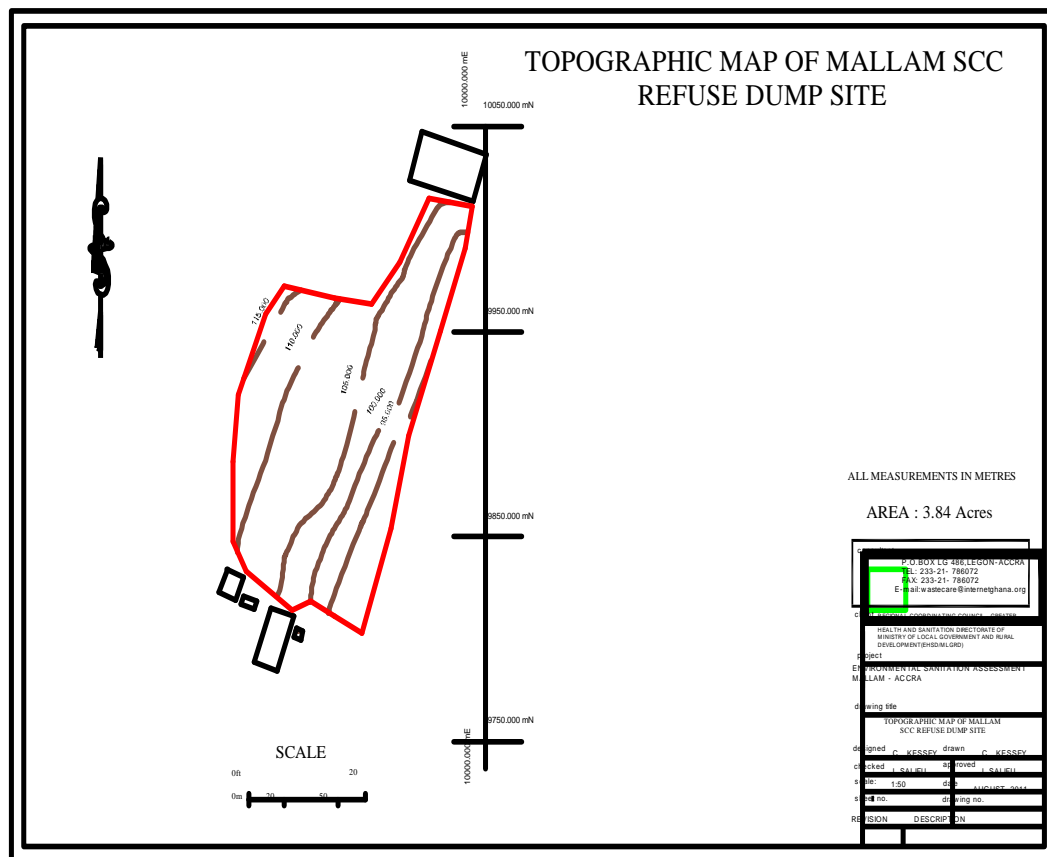
Figure 2: Topographic Map of Mallam SCC Refuse dumpsite
