GA SOUTH (WEIJA) MUNICIPAL ASSEMBLY

(FACILITY OPERATION AND MAINTENANCE HANDBOOK)

MALLAM MAIN, MALLAM SCC, OBLOGO No.1 AND SARBAH
REHABILITATED DUMPSITES

REHABILITATION OF DUMPSITES

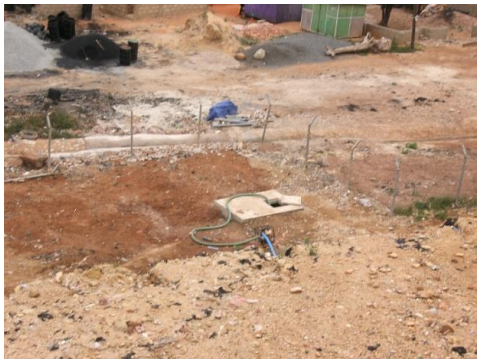
All the sites have a reinforced concrete tank (sump) at the lowest point of the site to facilitate easy collection of leachate by gravity.

Possible Defects	Mitigation measures	
<p><i>Reduction in the tank volume:</i> This is due to sedimentation of sand and/or other suspended particles</p>	<ul style="list-style-type: none"> • Level of leachate in sump should be checked frequently especially in the rainy season where leachate production is expected to increase; • Pumping should be done periodically to prevent tank overflow • The surface of the sump should not be covered /submerged totally with soil to ensure easy access to tank outlet • No excavation should be done around the sump. • Desludge the tank every 5years

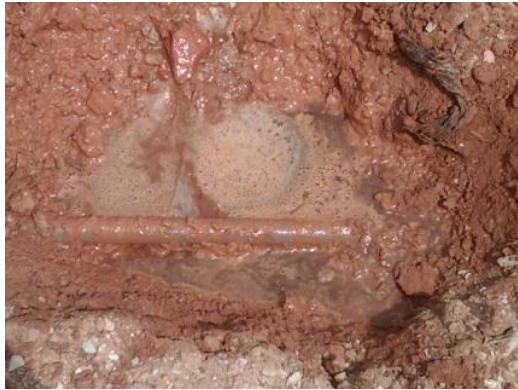
The Transmission pipe consists of a series of connected non-perforated PVC pipes and conveys leachate from the Sump into the Attenuation tank.

Possible defect	
<p>Pipe burst & Blockage: This may be caused by high internal/external pressure within or on the pipe. Pipe burst leads to the accumulation of sand in the pipe</p>

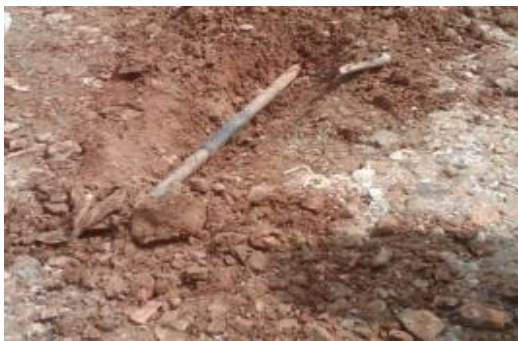
Mitigation Measure	
<p>Remove and replace burst/blocked section of the pipe</p>

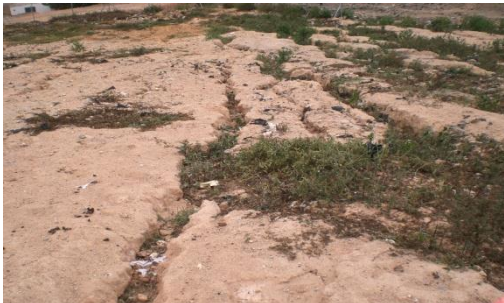
Possible Defects	Mitigation measures	
<p>Capped surface erosion:</p> <p>This is caused by surface run-off</p>	<p>The affected portion should be filled with appropriate cover material and well compacted</p>

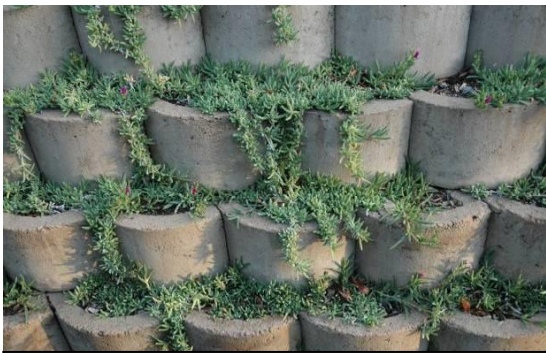
<p>Sloped surface Erosion:</p> <p>This is as a result of surface run-off or surface sliding due to poor compaction of sloped surfaces</p>	<p>Fill affected portion with laterite and ensure adequate compaction and stability.</p> <p>Provide good vegetation cover for the slope surface.</p> <p>Alternatively, hollow interlocking blocks can be placed along steep slope surfaces</p>

<p>Circular Interlocking Hollow blocks</p>

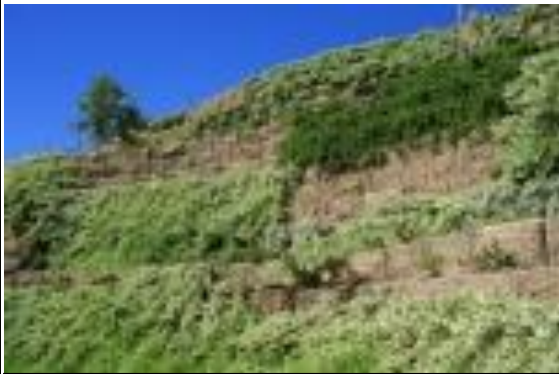
<p>Rectangular Interlocking Hollow blocks</p>
<p>Loss of vegetation cover:</p>	<p>Areas lacking sufficient vegetation cover must be reseeded.</p> <p>In some cases, soil amendments are added to help establish the native vegetation</p>

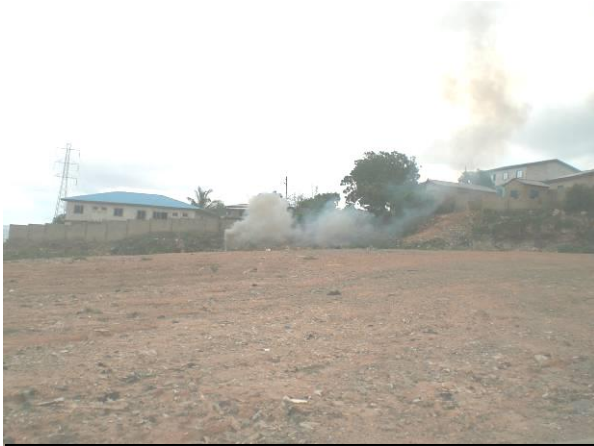
Landfill Gases (mainly Methane gas) are highly explosive and easily flammable. There is potential leakage of gases through the capped surface. Therefore no naked fire/flame should be lit around the site. These gases can be detected using gas monitoring probes. Also frequent checks on installed Gas Extraction System, if any should be done, to ensure its proper functioning

Emission of landfill gas from a blow-out hole

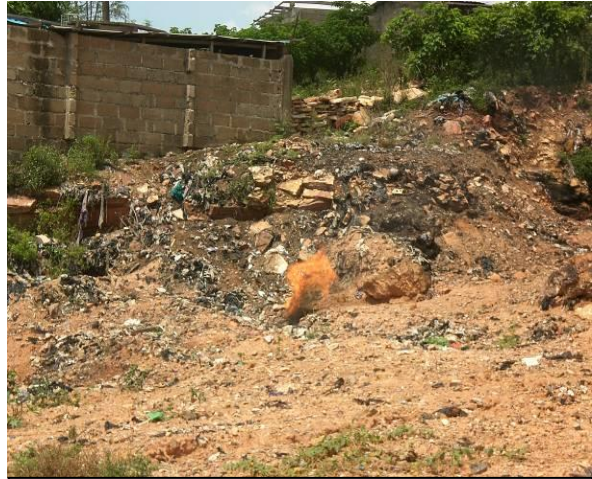
Ignited landfill gas

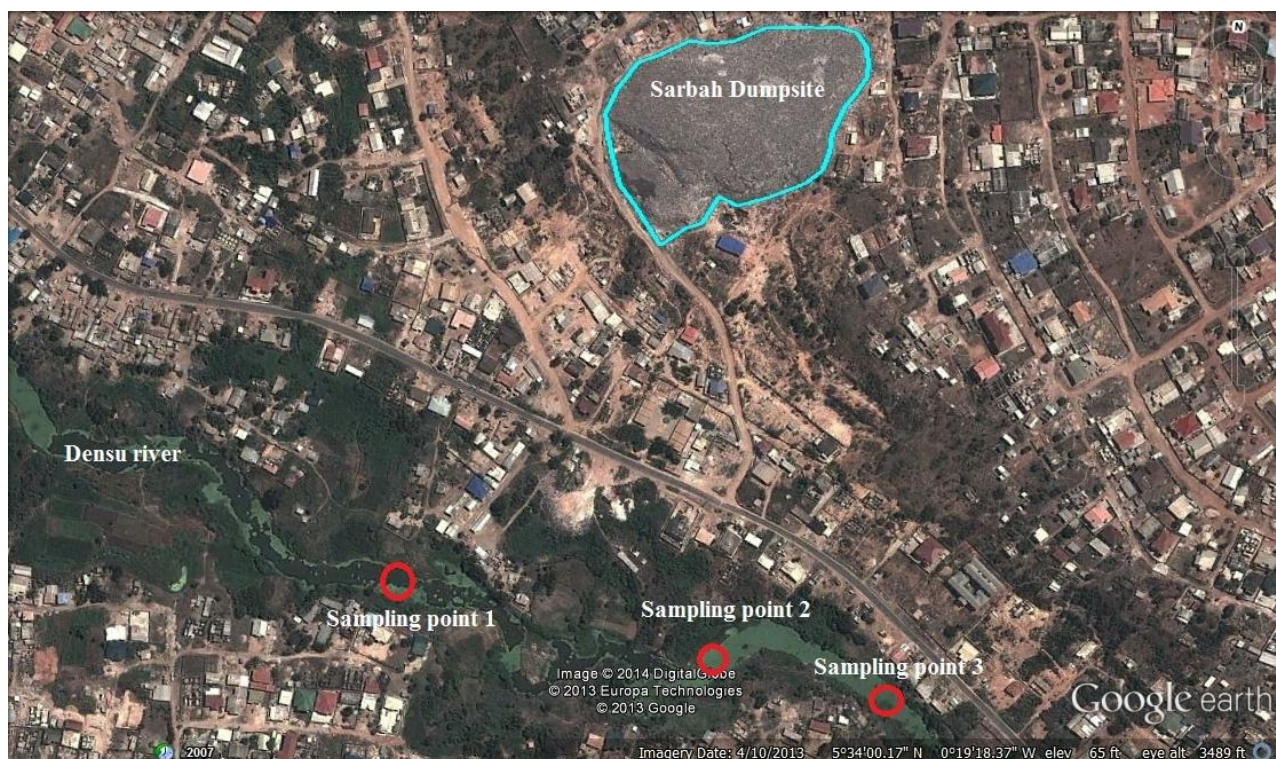
The drawing below shows sampling points for monitoring water quality of the Densu River

Sample point	Coordinates
Sample point 1	Latitude: 5°33'52.90" N Longitude: 0°19'23.61"W
Sample point 2	Latitude: 5°33'52.34" N Longitude: 0°19'14.73"W
Sample point 3	Latitude: 5°33'50.44" N Longitude: 0°19'09.05"W

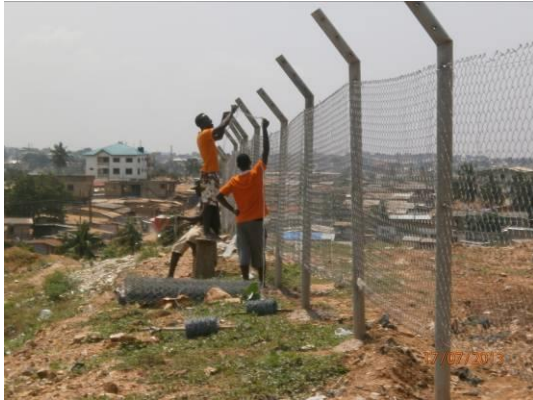
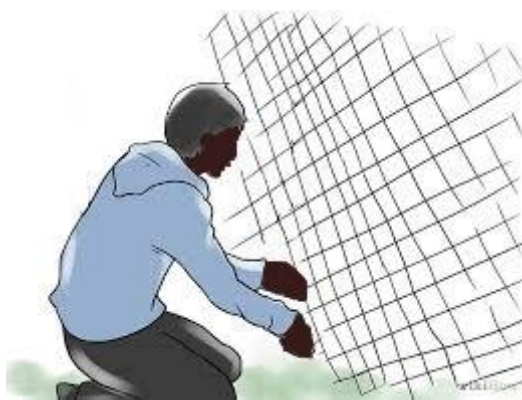
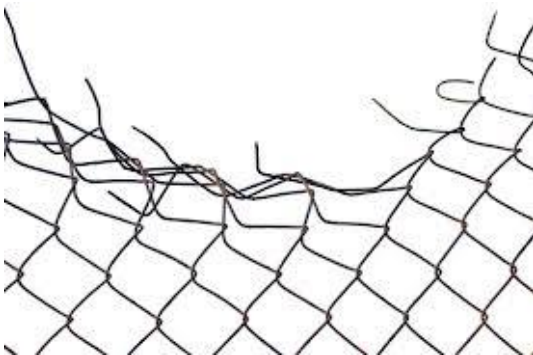
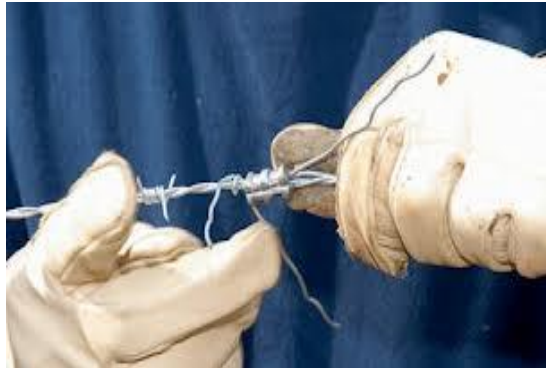
Repair/Replacement of damaged fence wires (Use protective gloves and pliers)

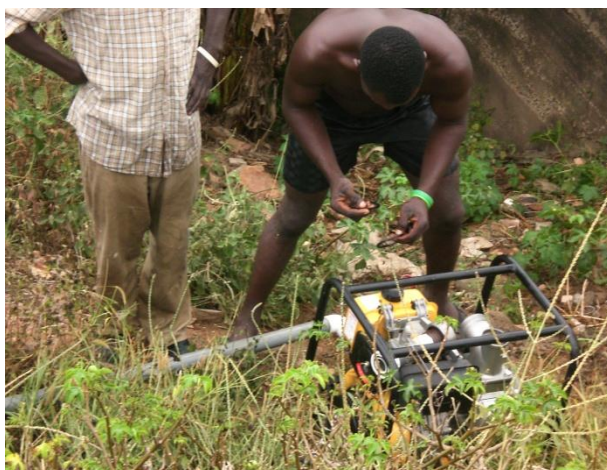
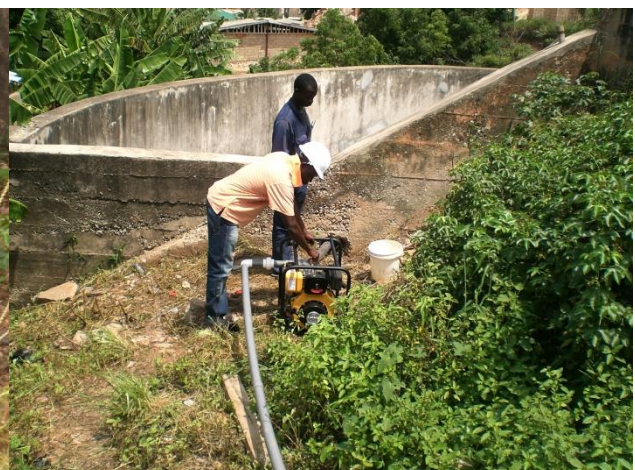
Pump should always be serviced, cleaned and greased and put in storage when not in used.

Coupling of the pipe should be securely fixed for efficient pumping

Each site installed with WC-SIRL has pumps for pumping leachate from the Sump into the Attenuation tank. It is important to service these pumps every 3 months
